# 1. Assessment

# Assess the building

## ... Typical Energy Audit Summary

### Valmont Square Recommendations and payback

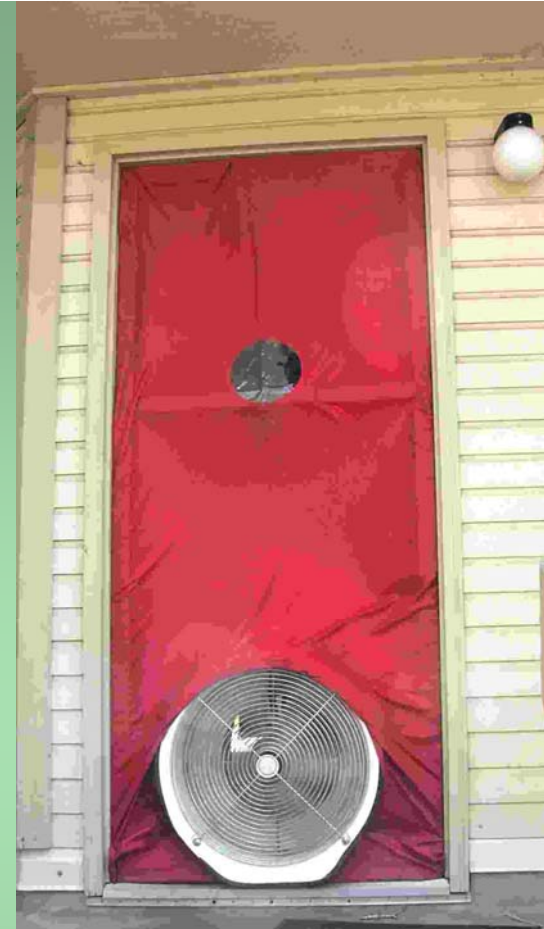
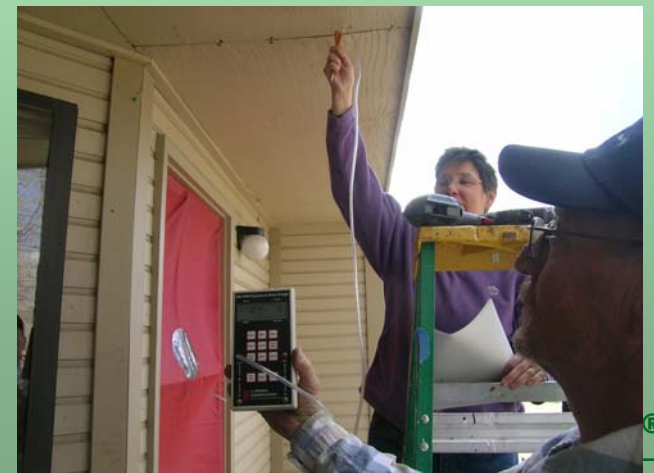
- 2000 CFM50, pretty leaky
- **Chimney** leaky even when the damper was closed
- Test over porch revealed that there's a clear **connection** between overhang and the envelope
- Later test with IR scanner showed similar problems with overhang of second floor on the south façade
